## TAYLOR BAY BEACH CLUB UPGRADES SEWAGE TREATMENT PLANT

### WHAT WE ARE DOING

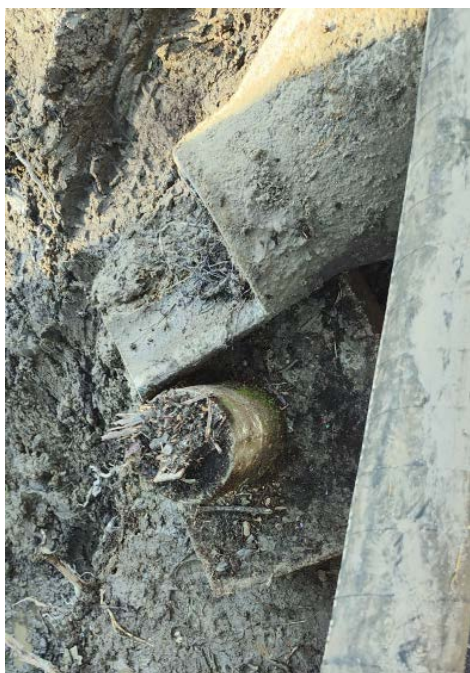
Some pipes were completely clogged with roots.

Fifty-year old leaky concrete sewer collection pipe was lined with new Cured in Place Plastic Pipe

- Total 6-inch pipe completed was 1,852 feet
- Total 8-inch pipe completed was 4,115 feet
- Two leaky manholes were regouted
- All 6-in and 8-in cleanouts were located and capped

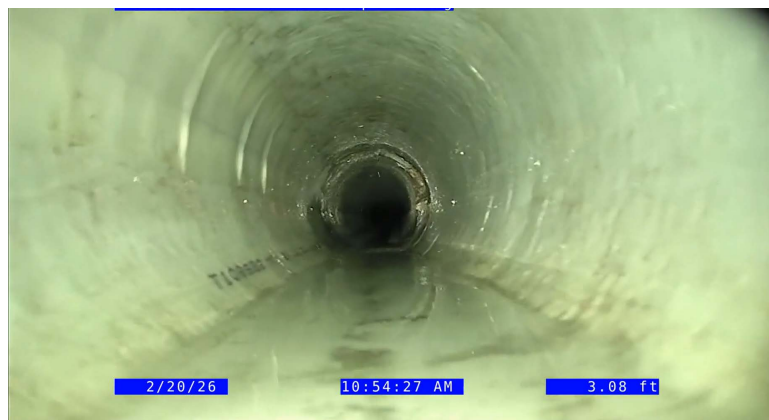
Most of the old 6-inch and 8-inch pipe was relined with cured in place plastic pipe.
